National Mall and Memorial Parks
Washington, D.C.

Photographs of Existing Conditions Pennsylvania Avenue National Historic Site

2006–2011

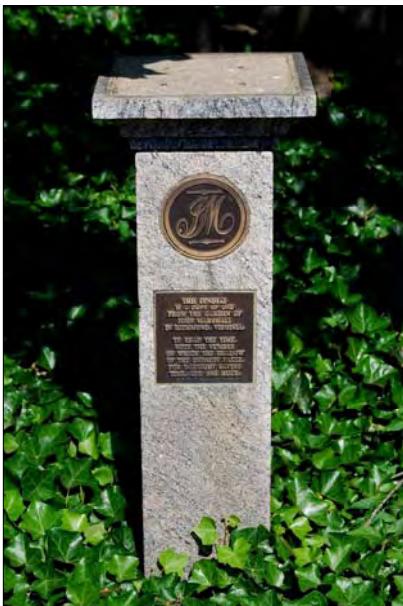
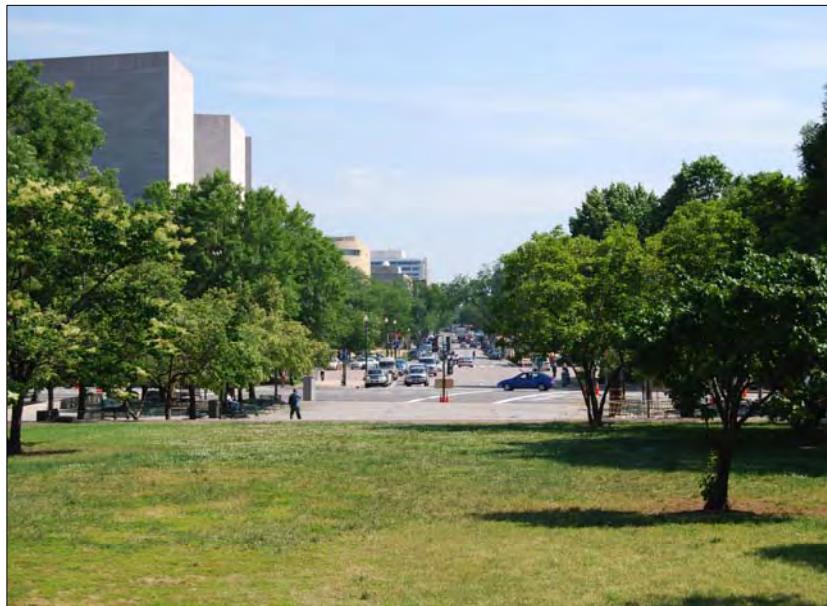
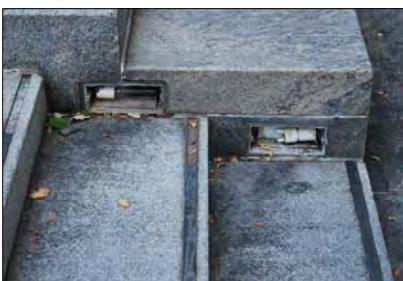
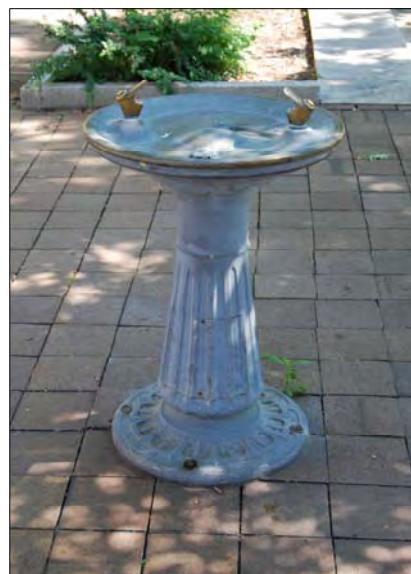
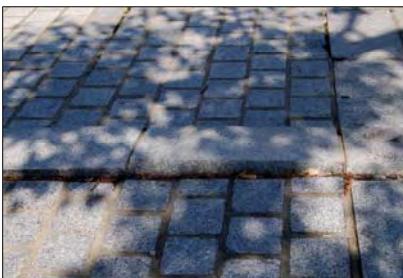
The park and its furnishings have deteriorated. Proposed rehabilitation offers opportunities to improve the park and provide additional education about the judiciary.

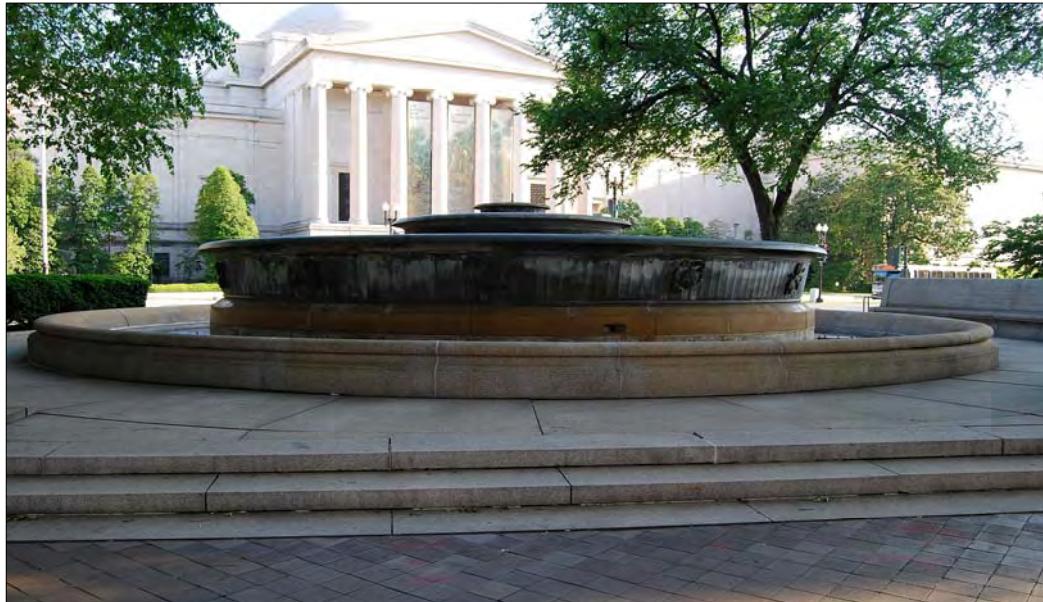
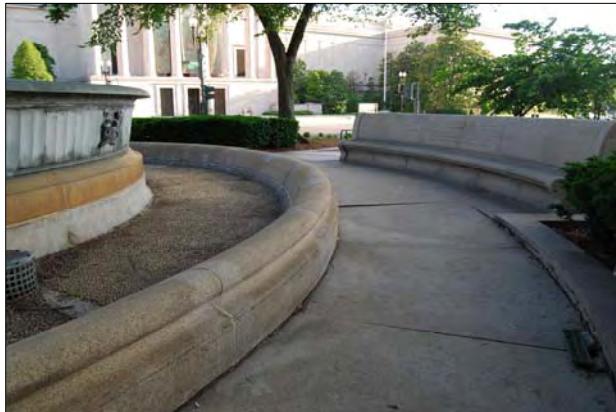
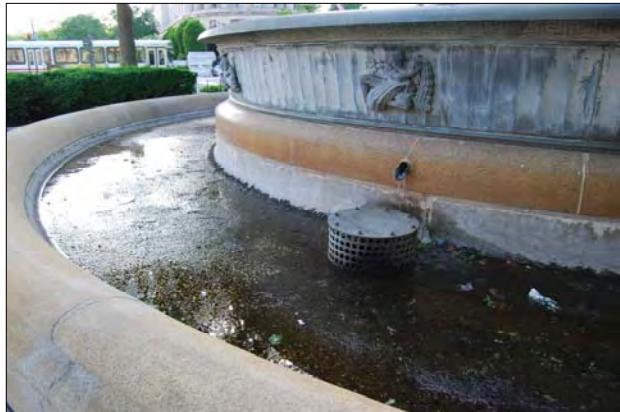
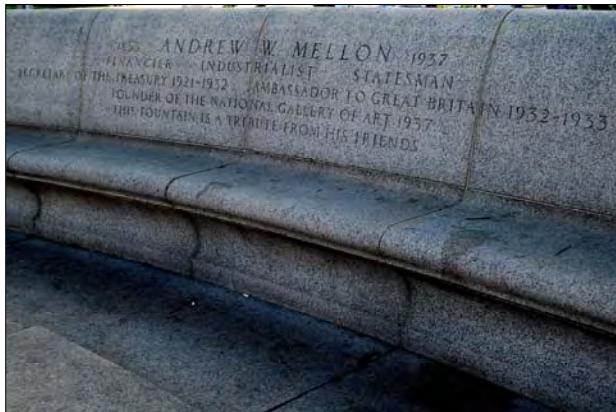
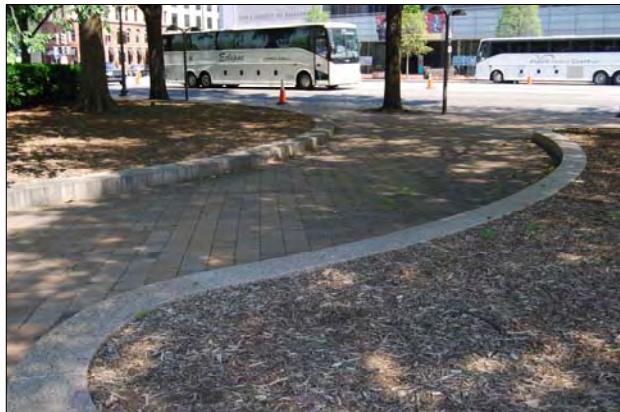
The fountain needs to be repaired and regularly maintained. Adjacent walks are paved with bricks, and curvilinear granite curbs surround street tree plantings.

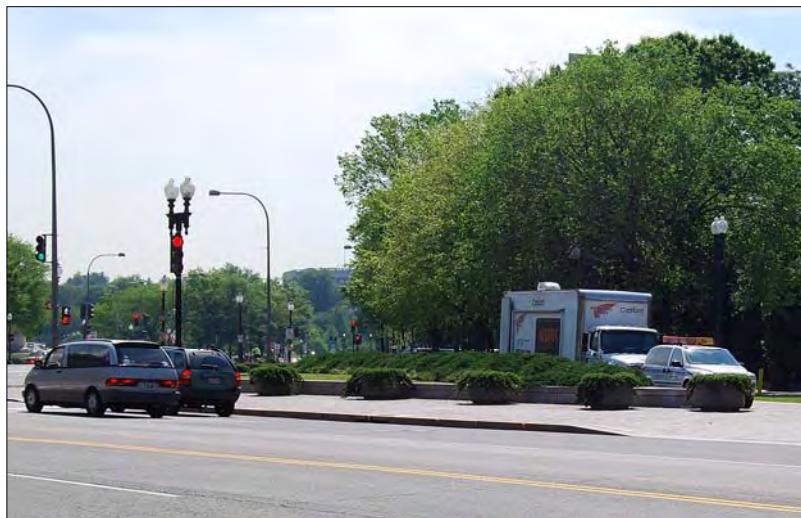
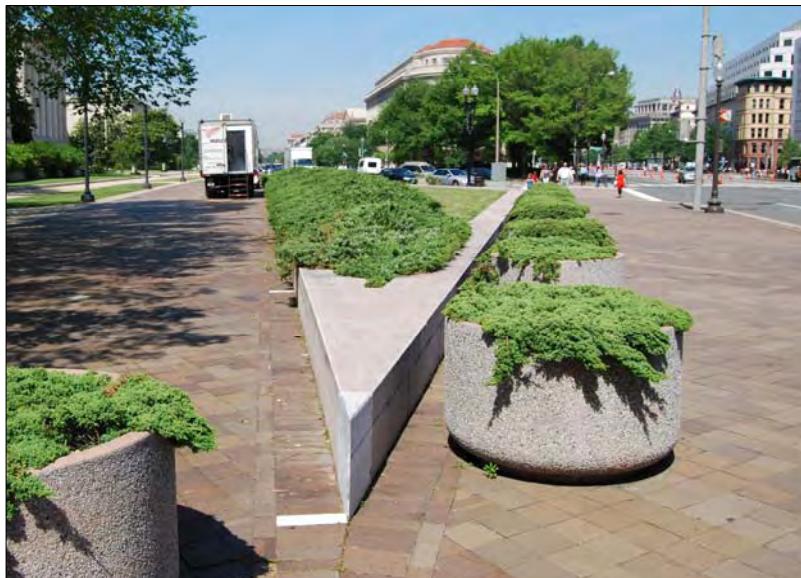
A triangular planting area, designed by I. M. Pei, is southeast of the Mellon Fountain, adjacent to the National Gallery of Art. The Constitution Avenue side of the triangle has been damaged by traffic accidents.

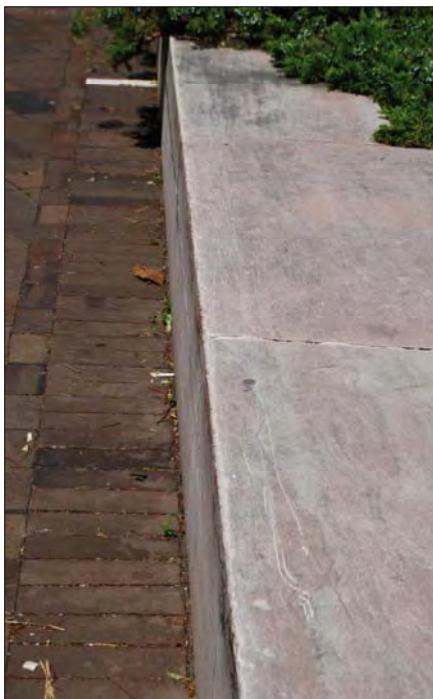
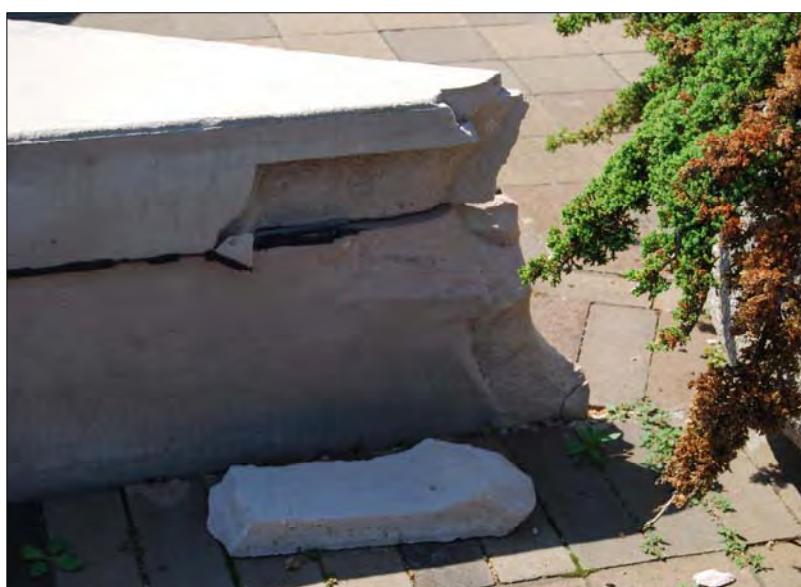
Skateboarding on top of the planter walls has also damaged the stonework.

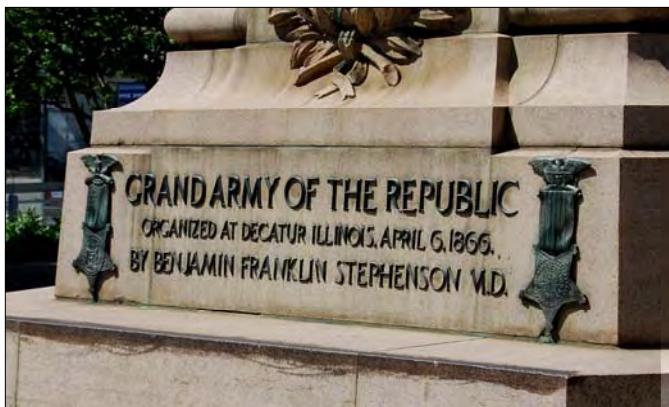
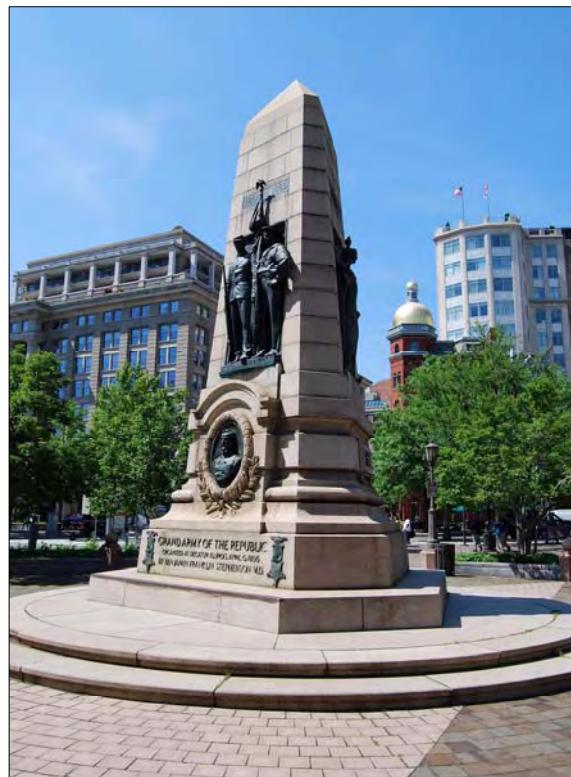
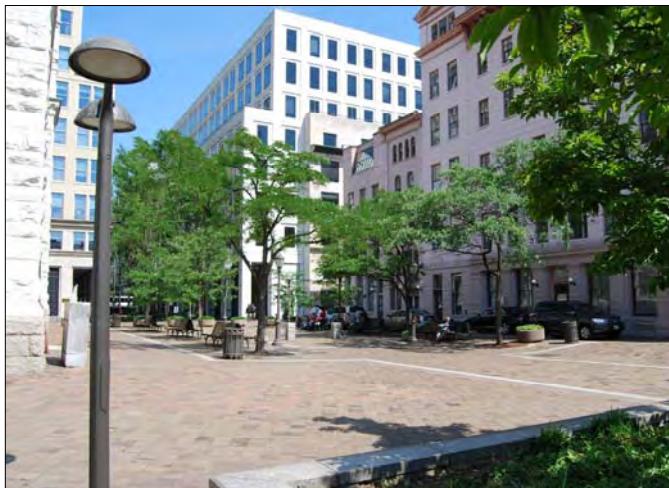
The plaza has an unkempt appearance, some adjacent lighting does not function, and skateboard damage is evident on walls and commemorative features.

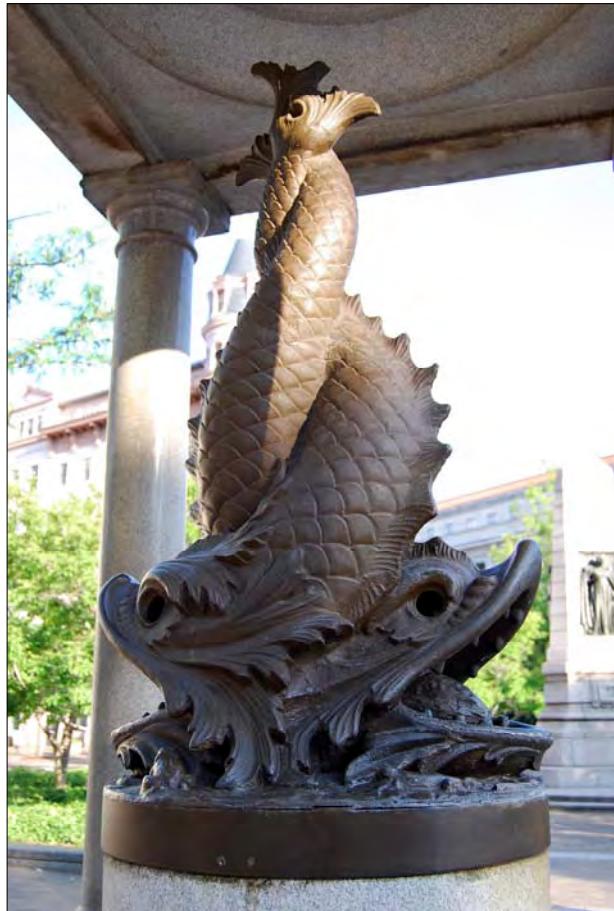
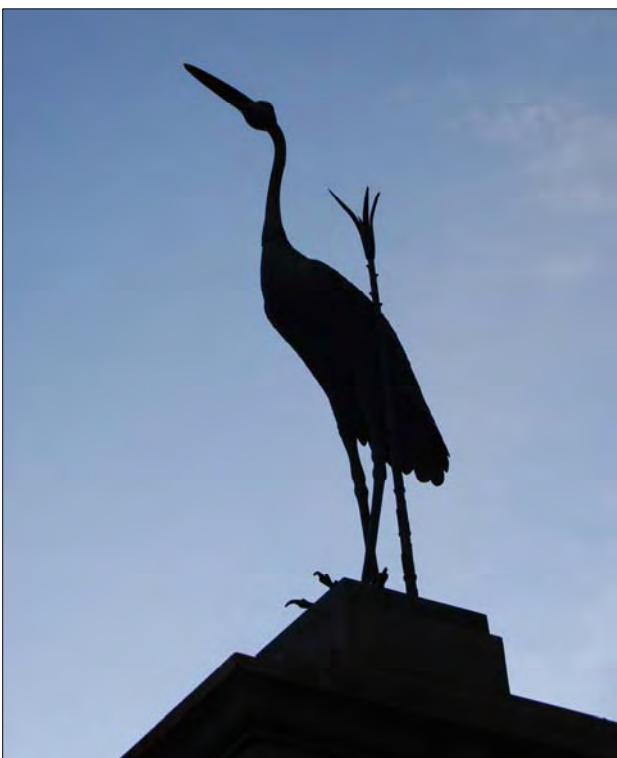
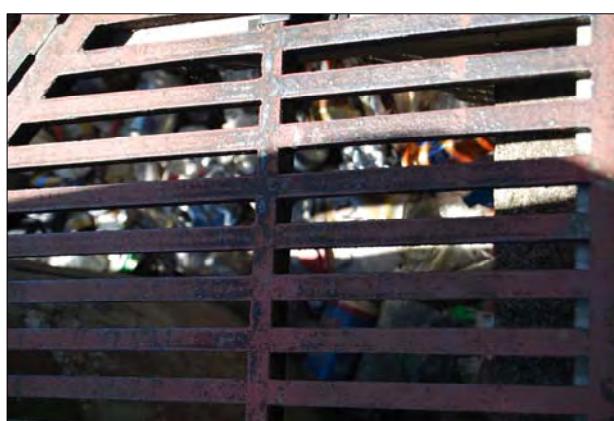
Litter collects beneath the grate around the base of the fountain.

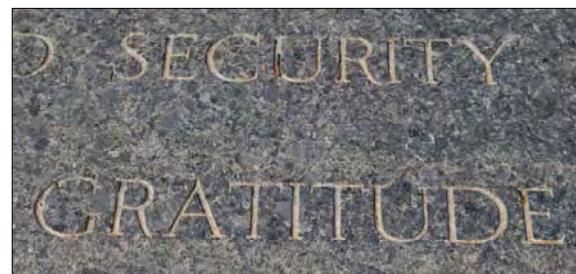
Custom designed features at the memorial, such as these step lights, contribute to its uniqueness. However, it is difficult to stock and repair such features.

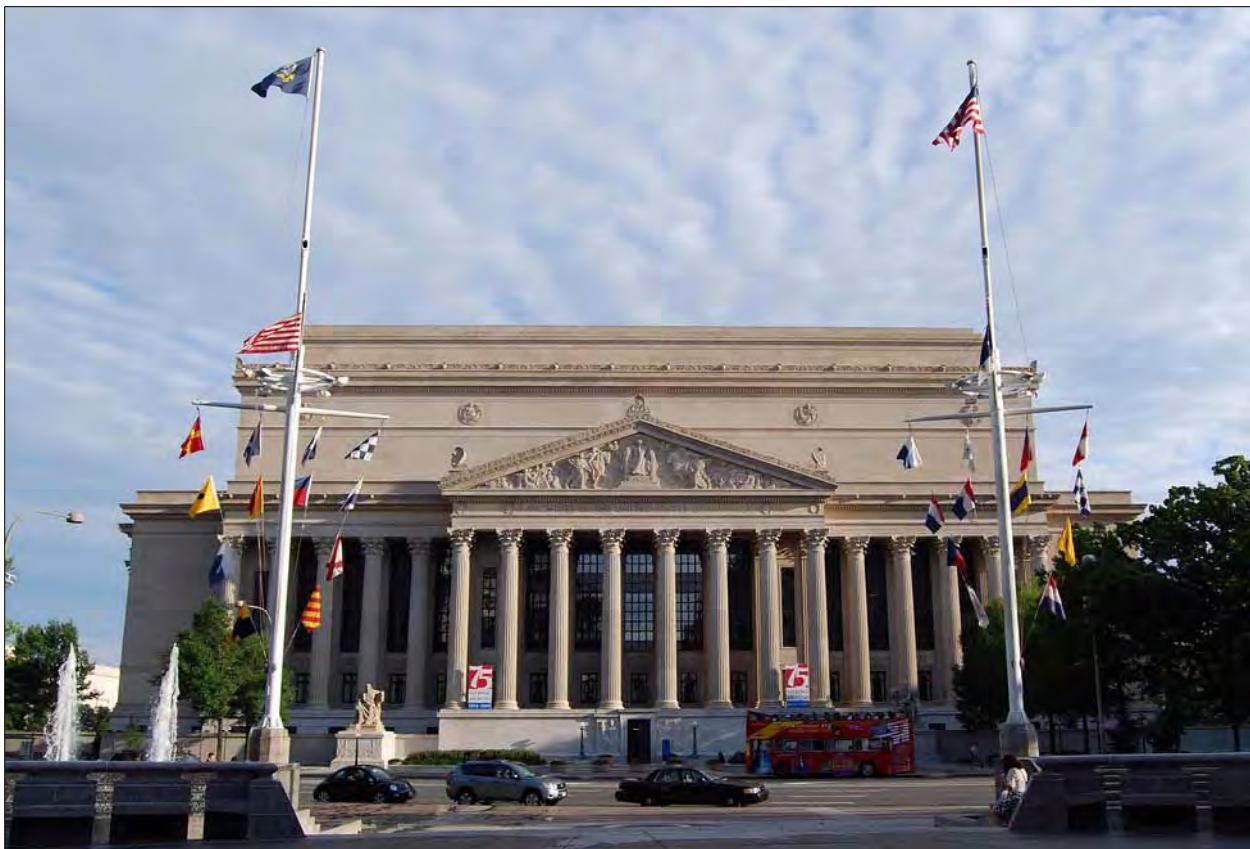
The north facade of the National Archives includes the research entry. The building is the terminus of views from Indiana Avenue, which is a tenet of the L'Enfant plan. Trees in front of the building have not been replanted.

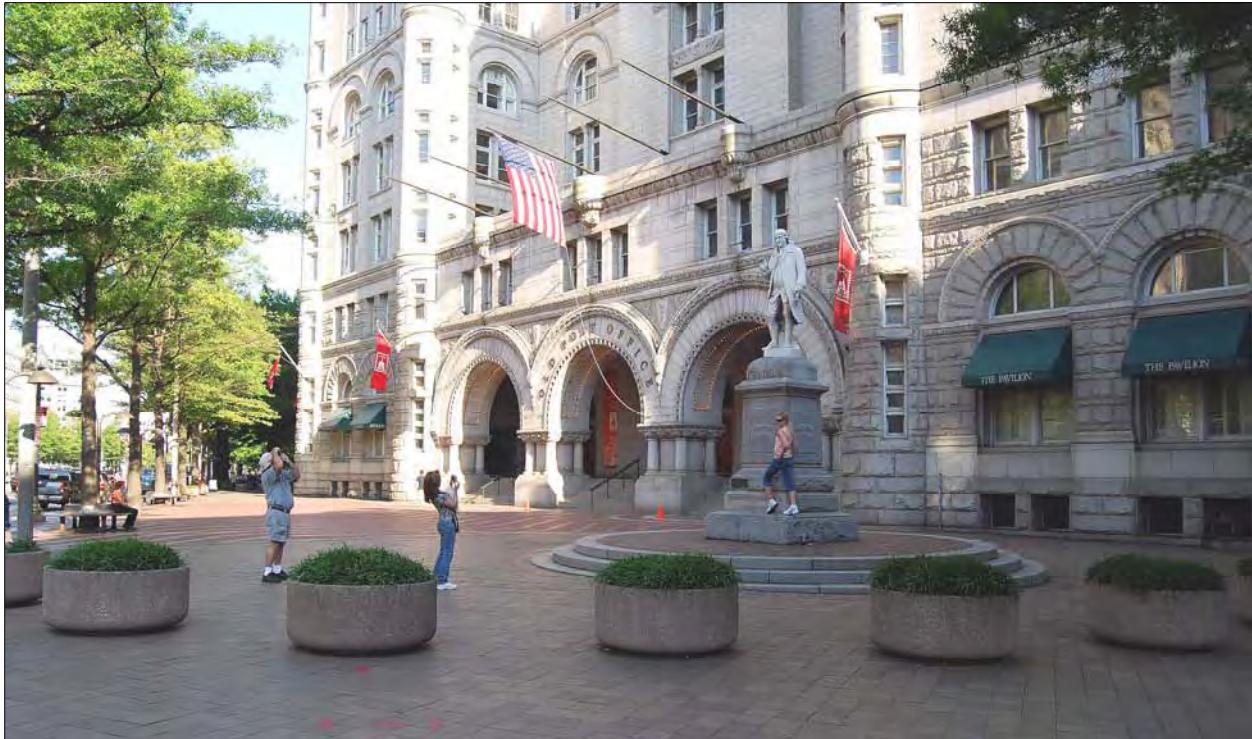
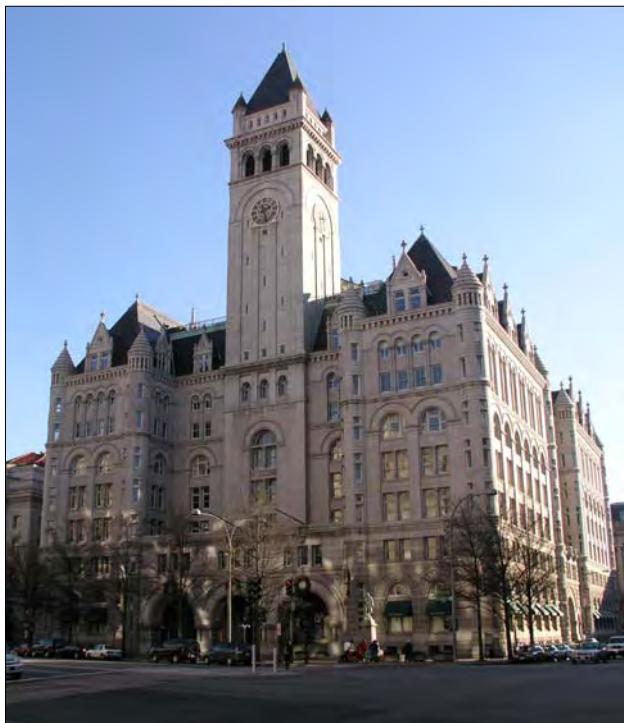
The Benjamin Franklin Plaza is on the southeast corner of 12th and Pennsylvania Avenue, in front of the Old Post Office Building. At midday in summer the lack of shade in the plaza can be a problem for visitors.

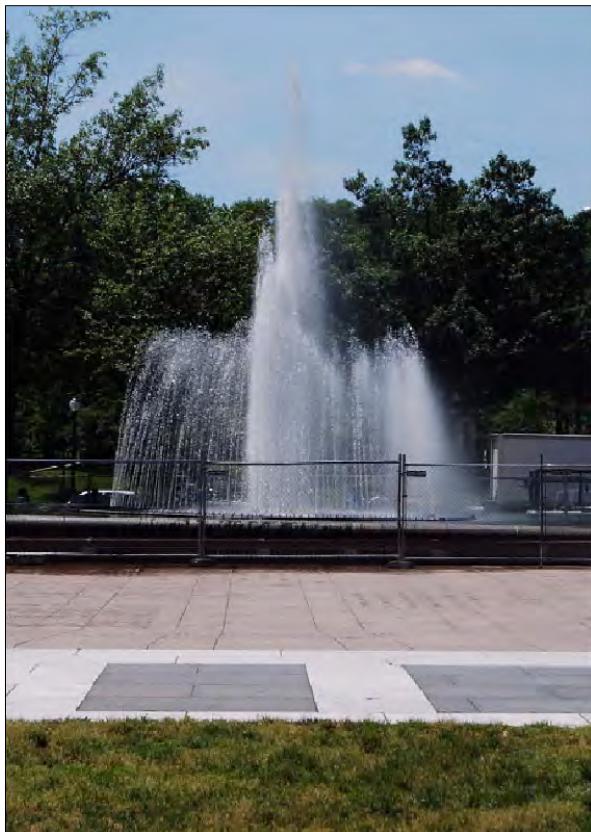
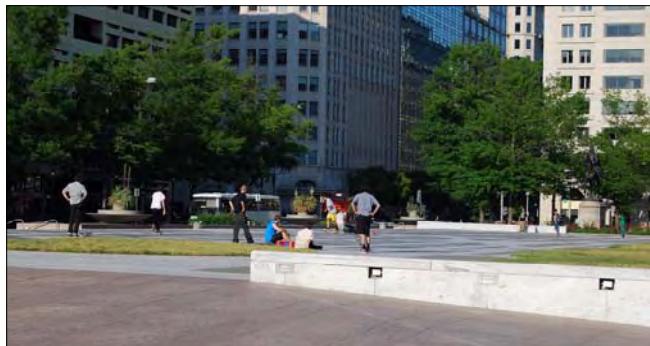
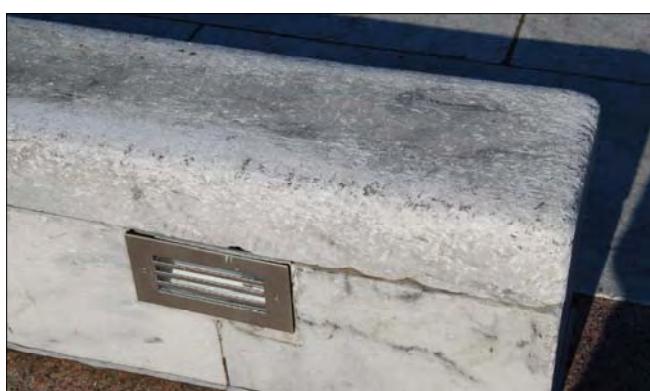
The fountain at 14th Street is difficult to operate. Frequent skateboarding has damaged the walls and steps.

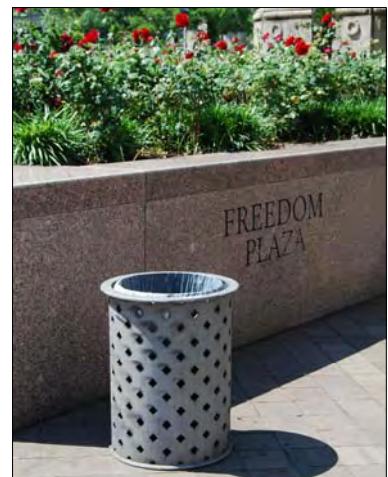
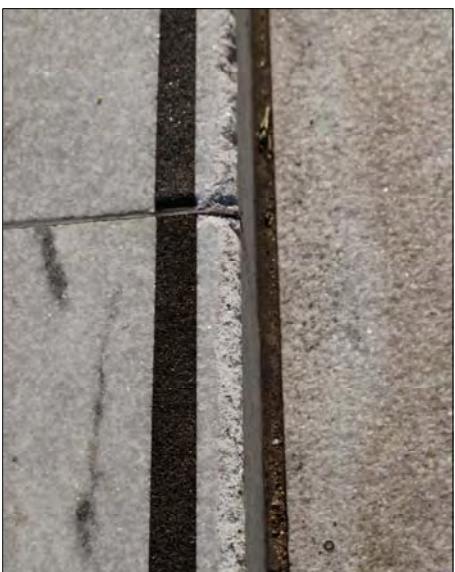
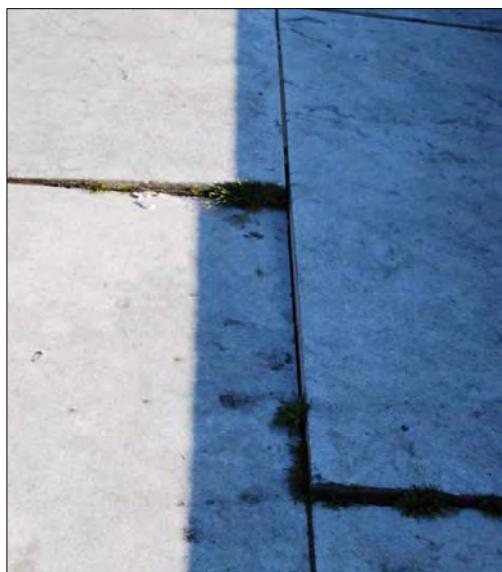
Paving is uneven and shows damage from skateboarding.

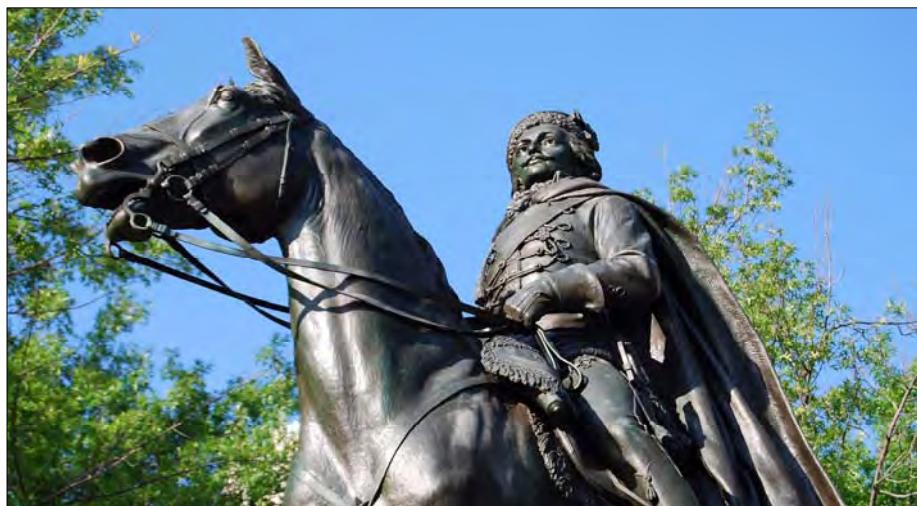
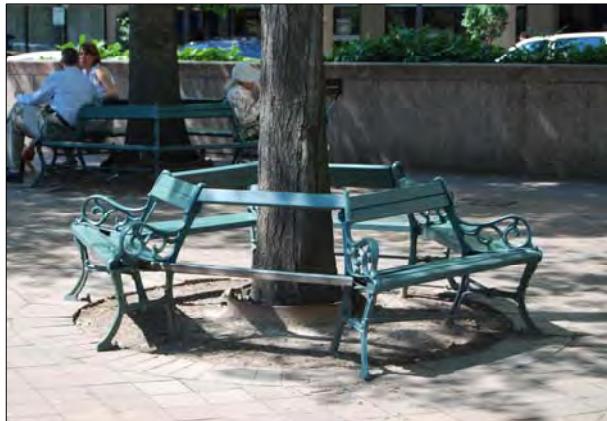
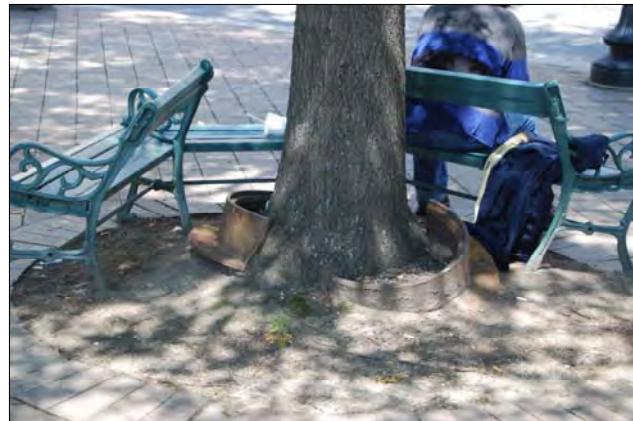
Due to skateboard damage, some benches around the Pulaski statue are missing slats or backs, or entire benches may be gone. Tree grates have been partially removed when outgrown.

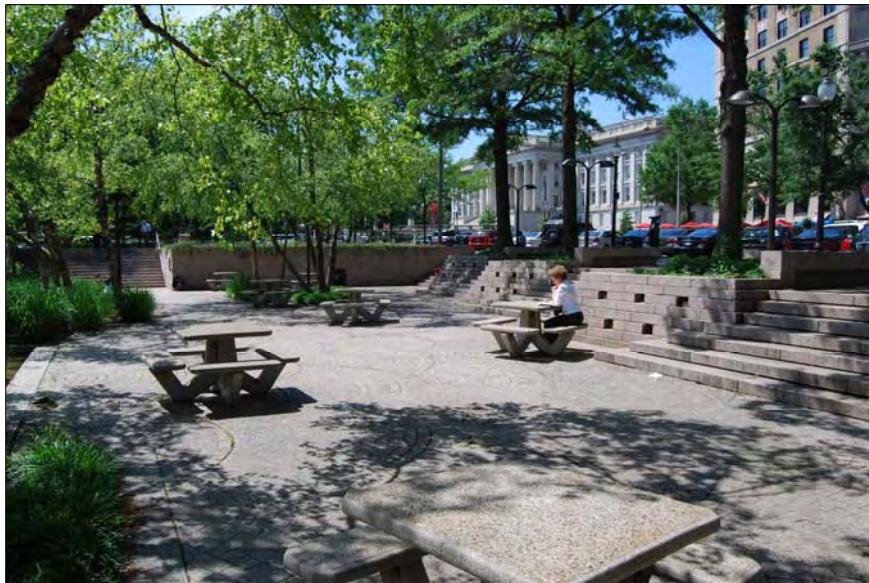
Some park furnishings, such as concrete tables, are not compatible with the character of other Pennsylvania Avenue street furnishings.

Water quality in the pool has been an ongoing problem.

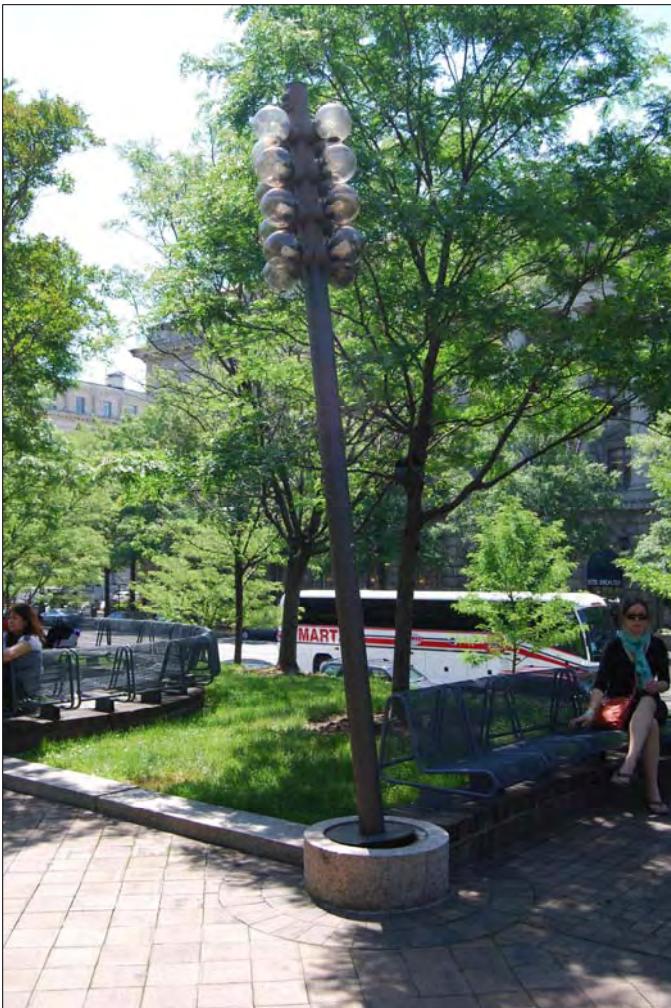
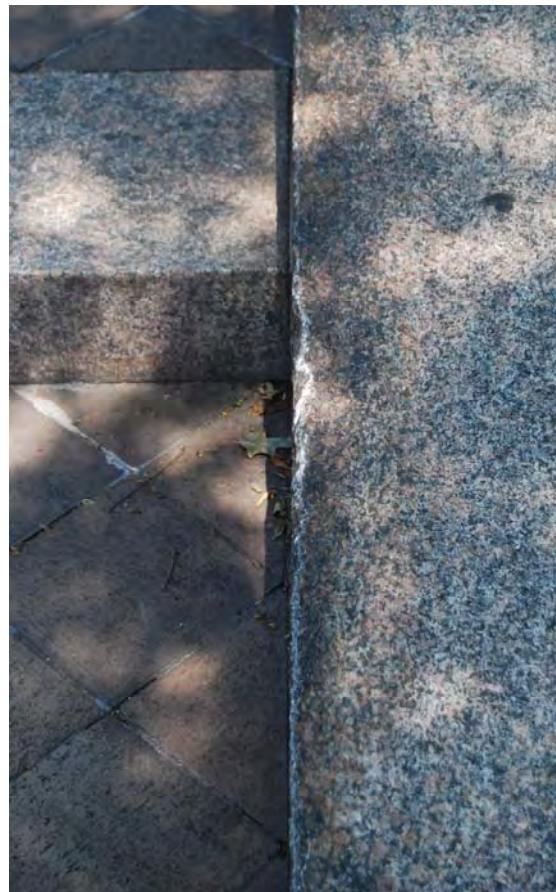
Some lampposts are out of alignment. Low places collect water, making tables unusable. Skateboarding has damaged granite curbing (above).

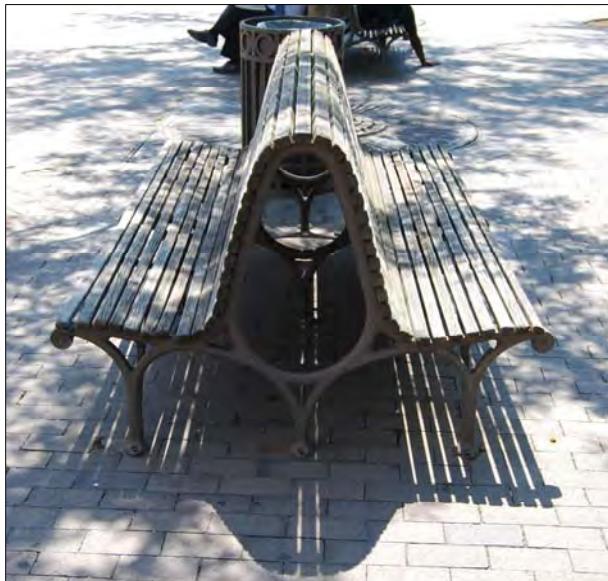
The Pennsylvania Avenue double wood bench dates from the PADC era. The benches are not universally accessible. Businesses sometimes add unauthorized embellishments.

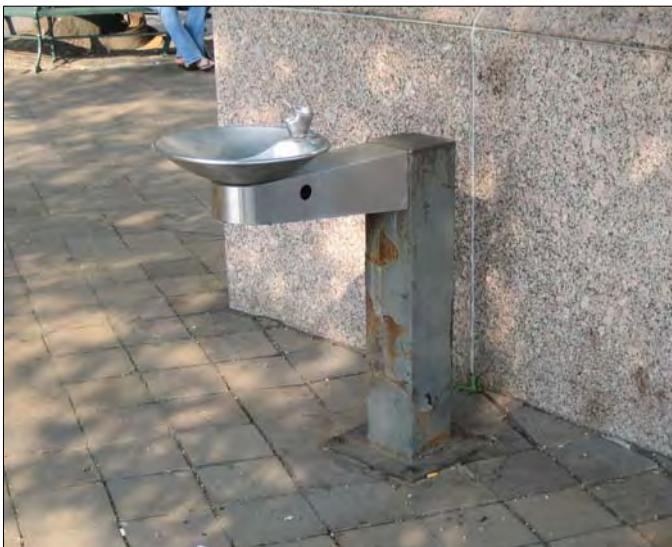
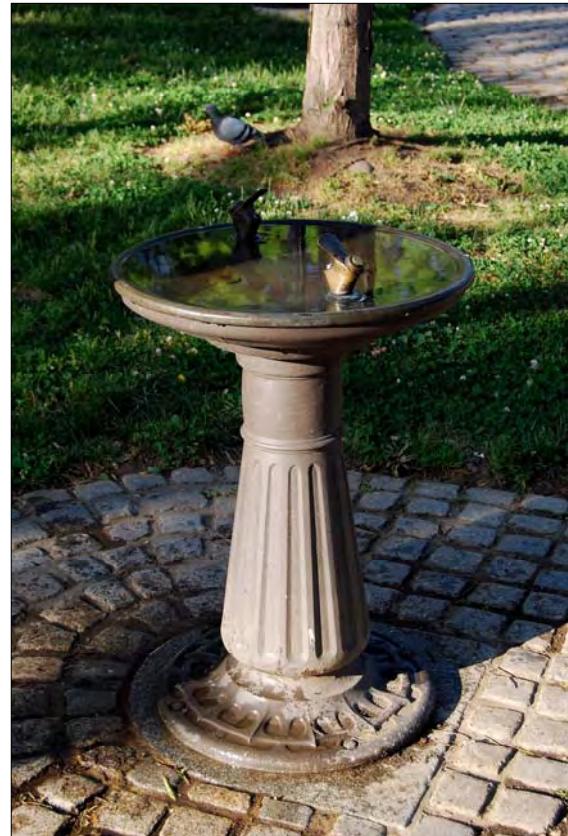
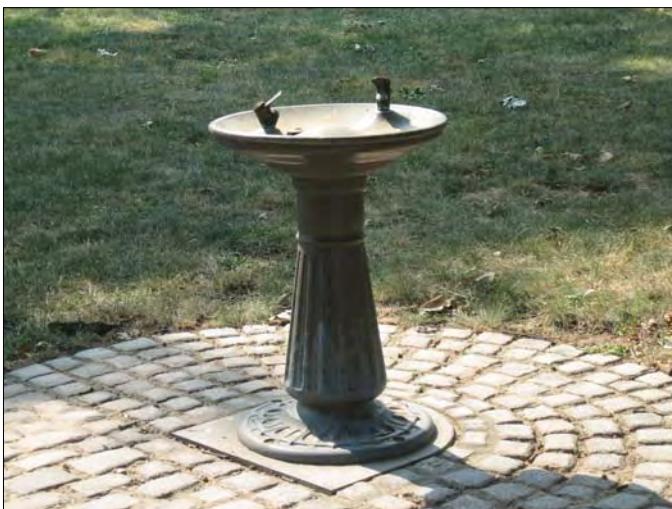
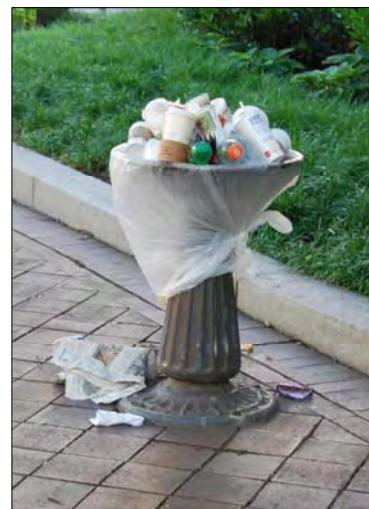
Maintenance is an ongoing problem. The photo to the left shows a covered, nonworking fountain that is being used as a trash container.

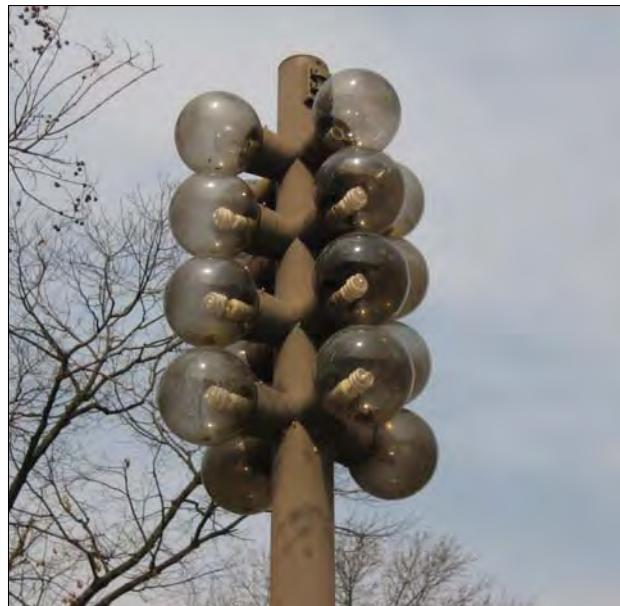
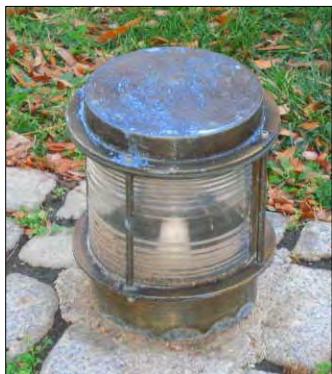
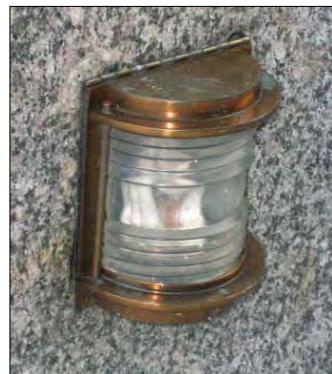
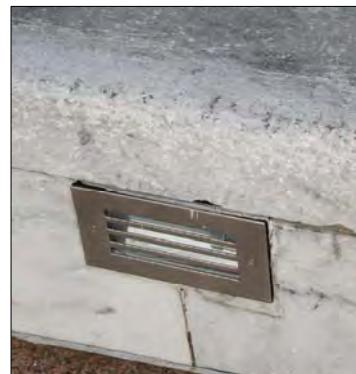
Parts for custom-designed lights at the U.S. Navy Memorial are expensive and difficult to stock.

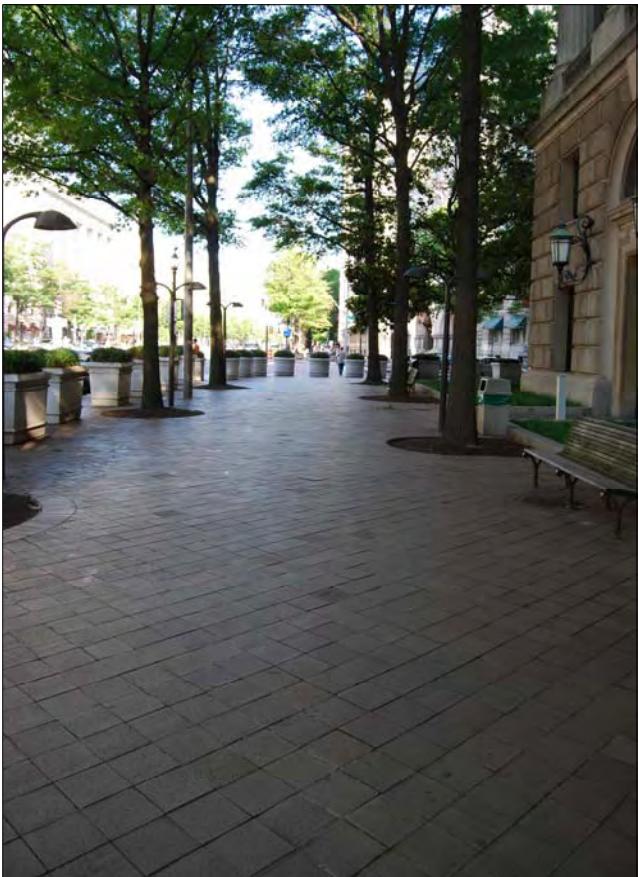
Concrete pavers are used along most of Pennsylvania Avenue's sidewalks. Missing pavers and chipped or uneven pavers result in tripping hazards.

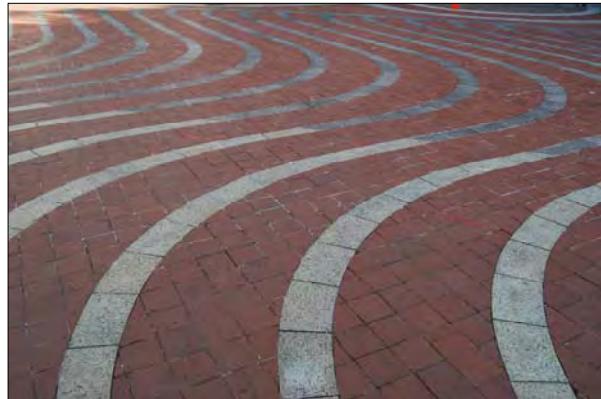
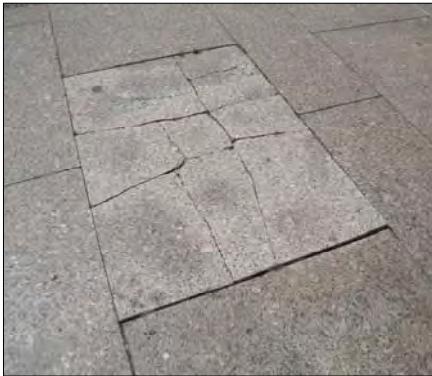
A granite paver in Freedom Plaza (above) is cracked. Paving at Indiana Plaza (right) combines brick and granite in a stacked bond pattern.

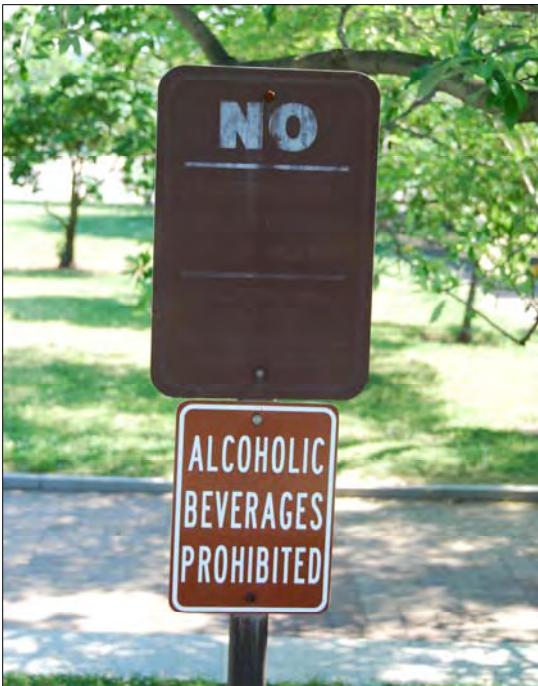
The NPS sign at John Marshall Park (left) has been defaced and the upper sign is illegible. The sign above is at the adjacent DC Courts building.

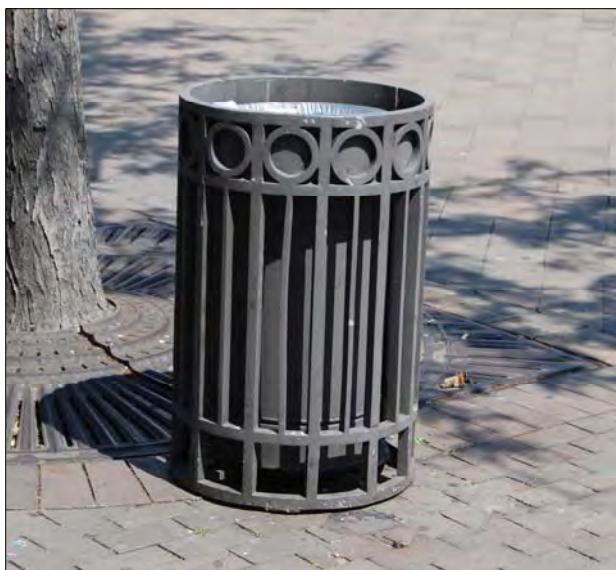
Trash containers were designed by the Pennsylvania Avenue Development Corporation. Routine maintenance, along with regular emptying, is needed.

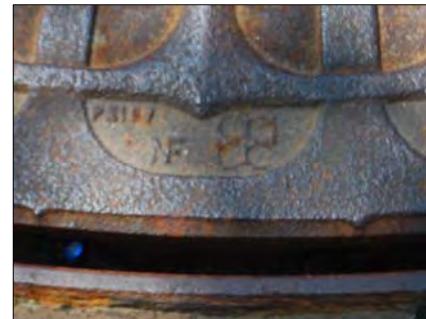
In some cases the inner rings of the grate were not cut away before the tree grew into them.
